## INSPECTION REPORT

1234 Main St. Knoxville TN 37922

10/05/2021 9:00AM

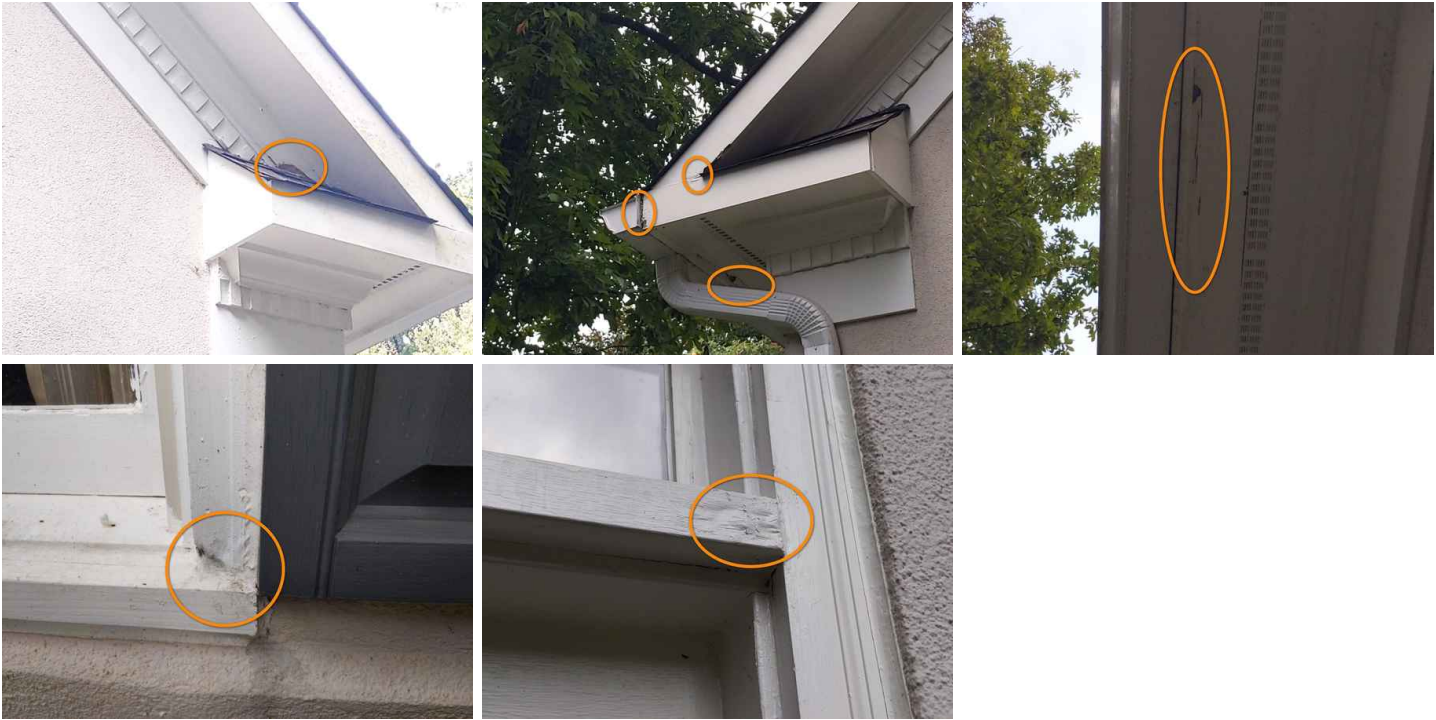
TRIM: DAMAGE

Wood trim damage was observed. Contact a contractor to evaluate and repair.

Contact a qualified professional.

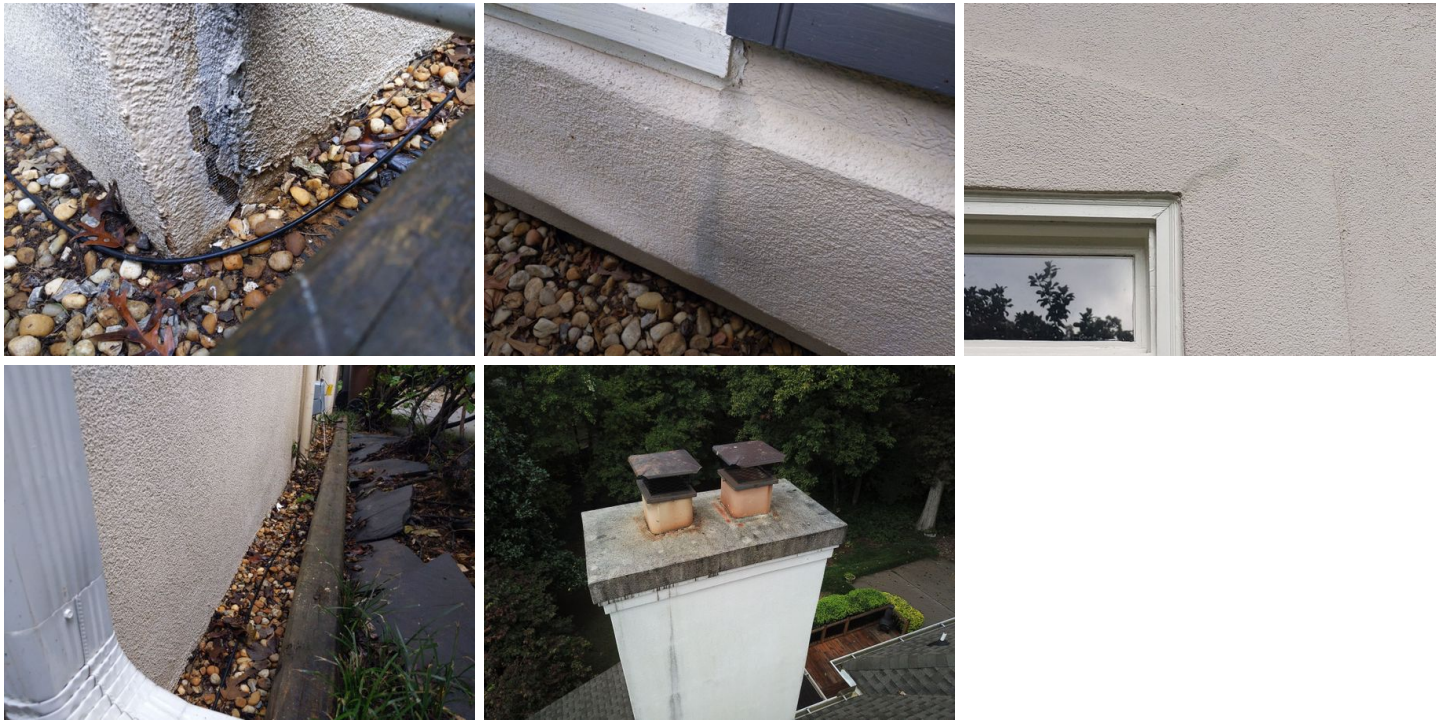
2.3.1 Stucco

CONCERNS WITH STUCCO

- 1. Some areas have been repaired. The information regarding these repairs should be obtained to ensure all areas of concern were properly addressed.
- 2. The EIFS does not maintain clearance to grade at the right side of the garage.
- 3. The stucco on the chimney crown is discolored. This does not appear to affect the functionality.

Recent testing and repairs have been performed. Consult with the stucco repairing contractor for further information regarding these items.

Recommendation  
Contact a stucco repair contractor

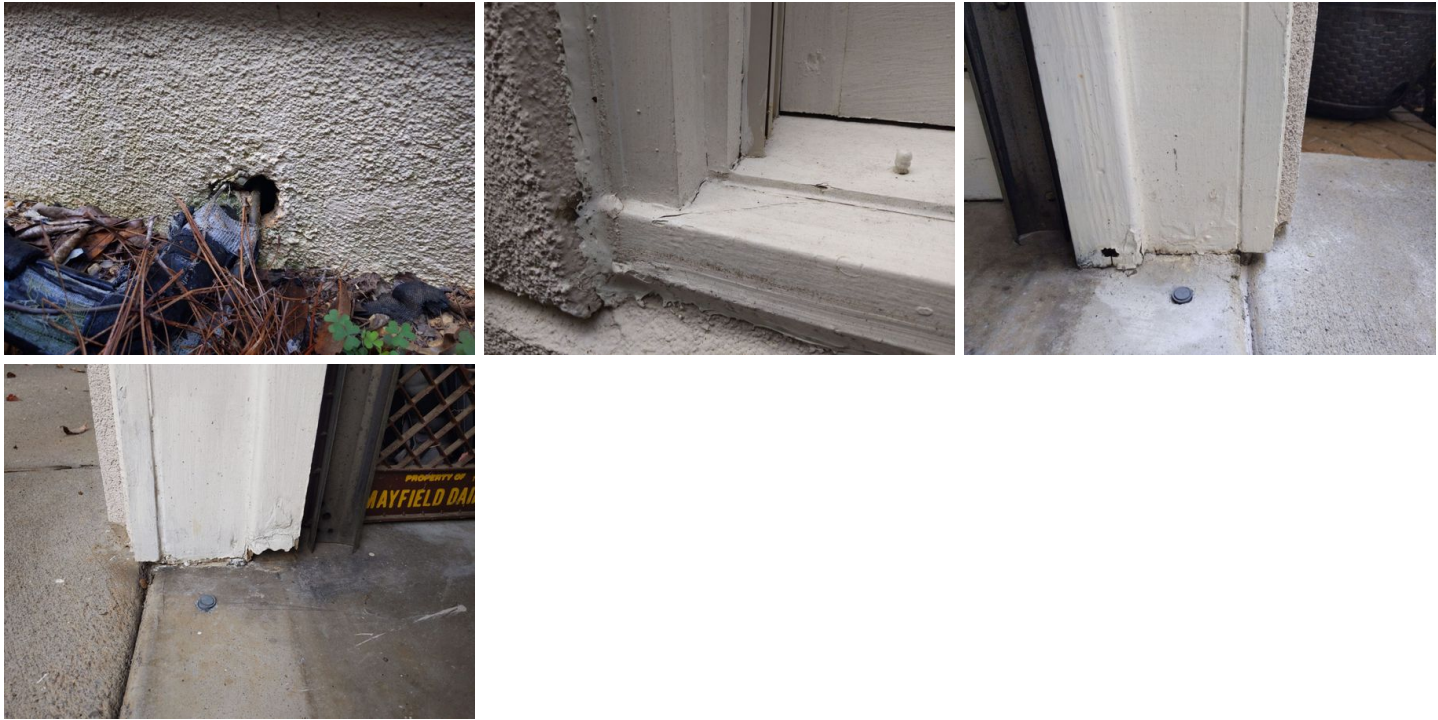
2.4.1 Penetrations

**CONCERNS WITH EXTERIOR PENETRATIONS**

- 1. There is an unsealed opening in the foundation wall behind the condenser unit on the left side.
- 2. The wood trim around the doors and windows should be kept caulked and painted to discourage water entry into the walls.

Consult with the appropriate qualified professionals to evaluate and repair as necessary.

Recommendation  
Contact a qualified professional.

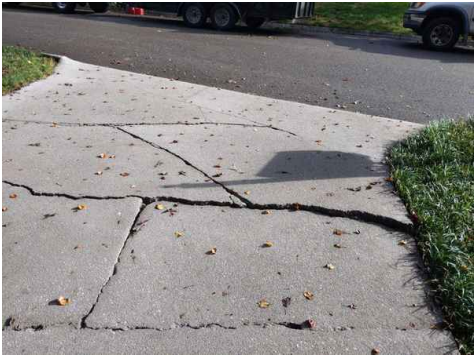
The concrete at the outer end of the driveway has cracked and offsetting is present (potential trip hazard). This may have been caused by tree roots growing below the surface. Consult with a qualified professional for repair options.

Recommendation  
Contact a qualified professional.

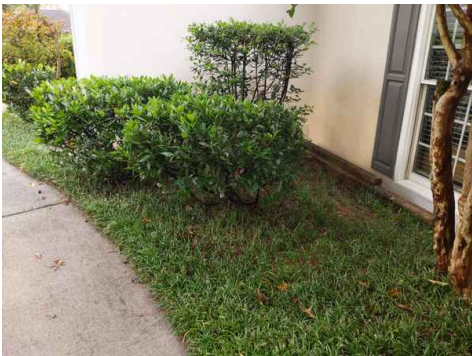
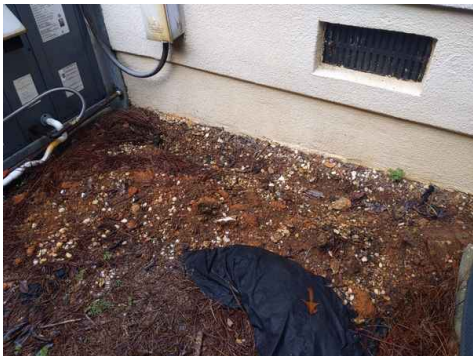
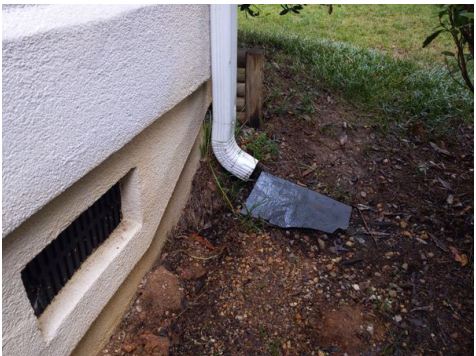
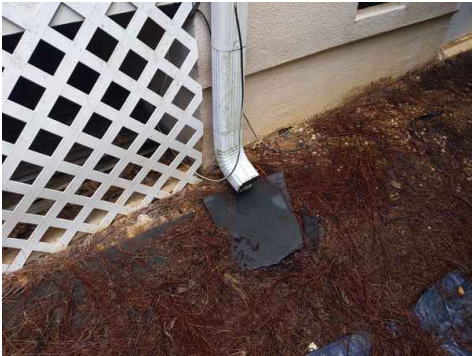
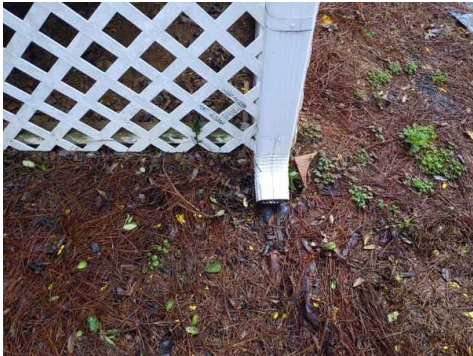
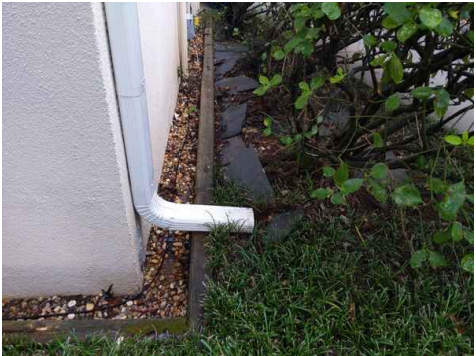
2.7.1 Grading and Drainage

**GRADING AND DRAINAGE CONCERNS**

There are issues with watershed and/or ground drainage on the exterior of the building. These concerns are listed above and in the photographs. Improperly controlling water on the exterior can lead to water intrusion and structural issues. Water from the roof, exterior surfaces, and grounds should be diverted away from the exterior walls and foundation.

Recommendation  
Contact a qualified professional.

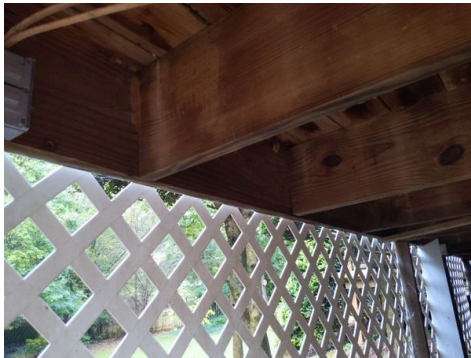
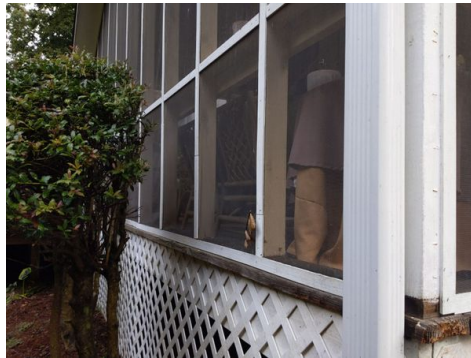
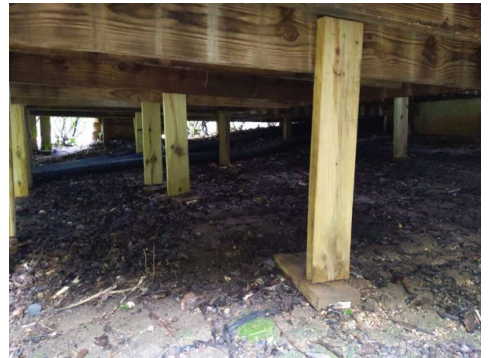
## 2.9.1 Deck

1. There are no hangers on the ends of various joists.
2. There are no guards in the rails at the screened area. Screening does not replace the necessity for guards in the openings.
3. Additional supports have been placed beneath the joists at the open area of the deck. These additional supports are installed in an unconventional manner (resting on cap blocks and attached to the sides of the joists).

Consult with a reputable deck contractor or qualified professional to make repairs on all items deemed necessary for the best safety and integrity.

Contact a qualified professional.

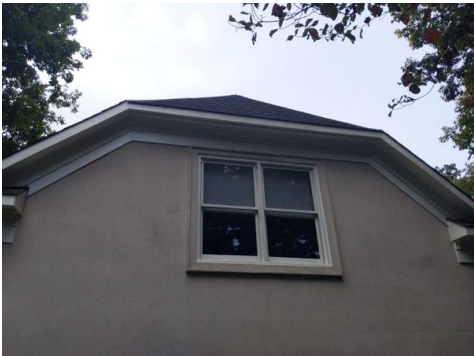
There is no gutter installed on the hip roof structure. This is common for this design. Installing gutters at this area could improve conditions by containing the water that runs off of the roof and carrying it away from the structure. Consult with a reputable gutter installation company if you wish to make this upgrade.

Recommendation  
Contact a qualified professional.

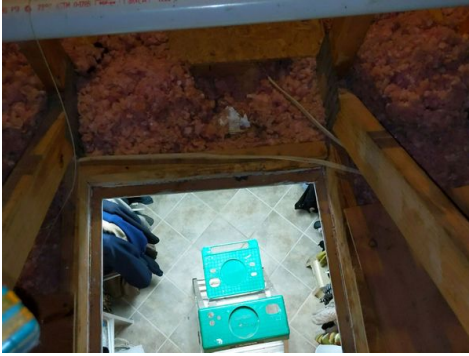
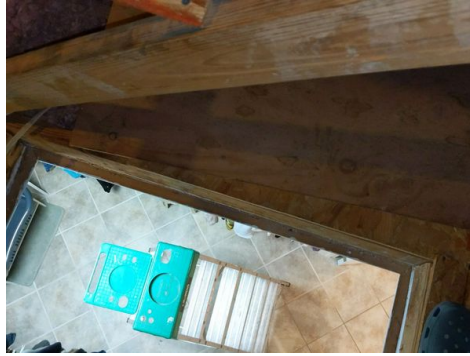
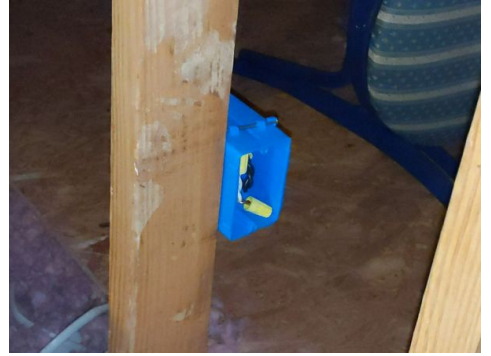
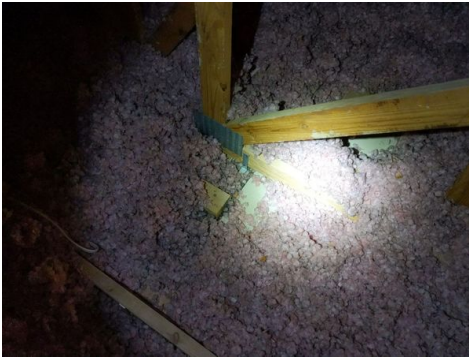
3.6.1 Attic

### CONCERNS IN ATTIC

Contact a qualified professional to evaluate and repair as necessary.

Contact a qualified professional.

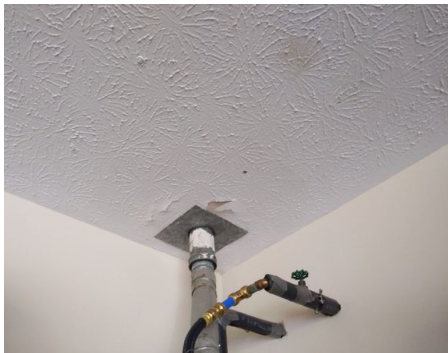
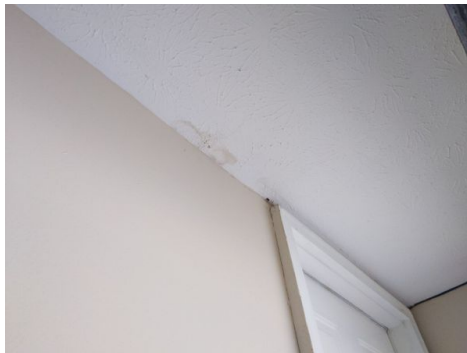
### Walls and Ceiling: Drywall Stains

Staining was observed on the drywall in the garage. A moisture meter was used and there were no elevated levels of moisture detected at the time of this inspection.

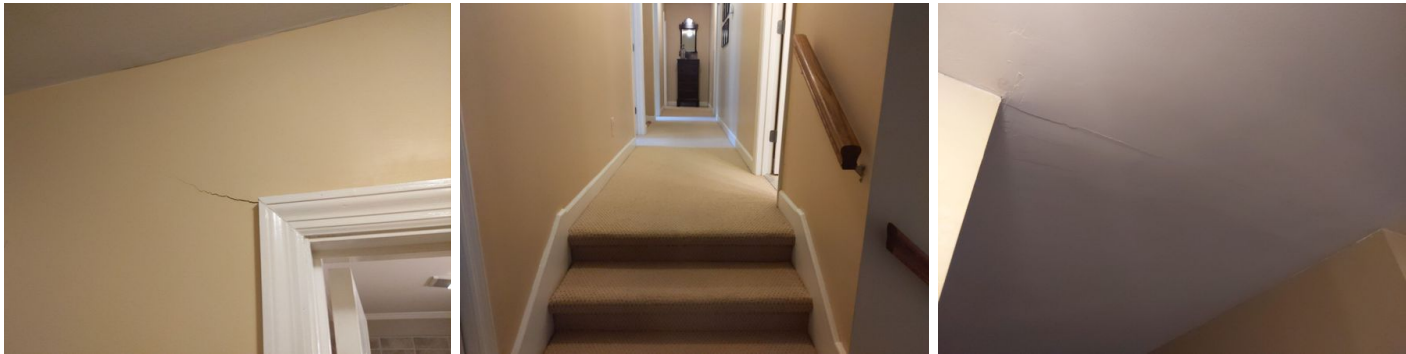
There are indications of settlement at various locations (i.e. floors are not level in some areas, cracks in the drywall, drywall repairs).

There are structural repairs that have been performed in the crawlspace. Obtain the documentation from the structural engineer and repairing contractor for further information.

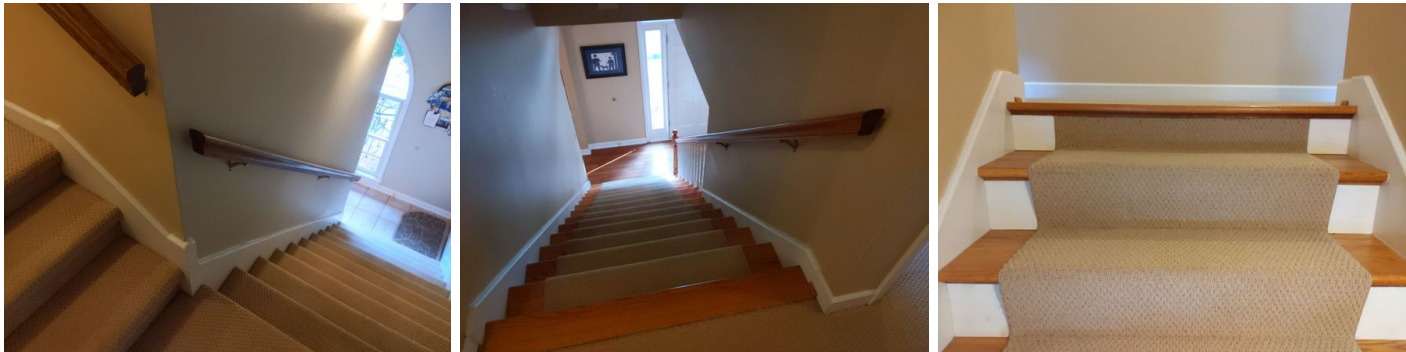
- Some aspects of the stairs and/or railings do not adhere to the current industry standards.
1. The staircase handrail does not return to the wall. This presents a safety hazard due to the potential for clothes or items to "catch" on the end of the rail and cause a fall on the staircase. According to current industry standards, handrail ends should be returned or should terminate in newel posts or safety terminals.
  2. The riser height of the stairs varies. According to current industry standards, the greatest riser height within any flight of stairs should not exceed the smallest by more than 3/8 inch.

Although this inspection is not intended to enforce adherence to any standard, the lack of conformity to the current industry standard may present a safety hazard. A qualified individual or company can make upgrades to improve safety if desired. *(Reference R311 and R312)*

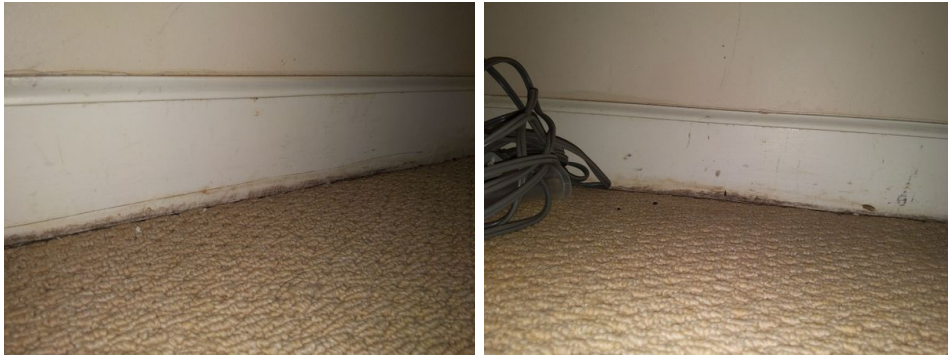
5.3.1 Walls and Ceilings

STAINS [INQUIRE]

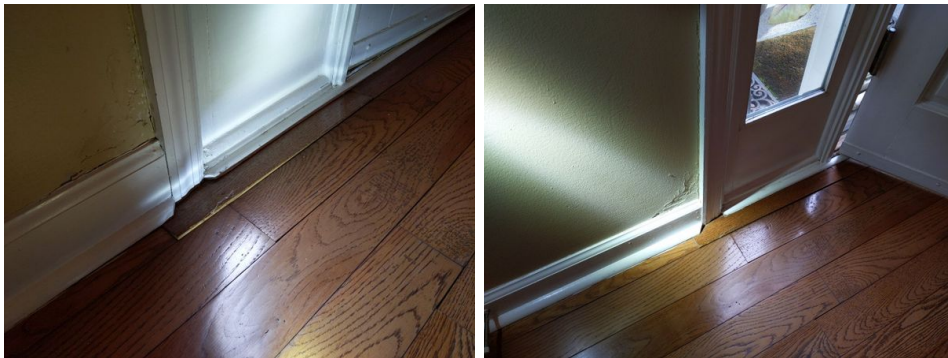
### 5.3.2 Walls and Ceilings

#### REPAIRS [INQUIRE]

Contact the seller for more info

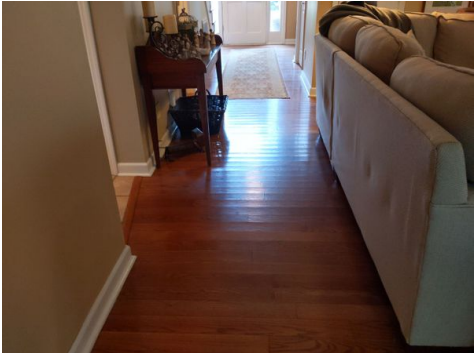
- 1. Areas of the floor are not level.
- 2. The hardwood floor is cupped on the main level. This may be related to humidity issues in the crawlspace.

Consult with the appropriate qualified professionals to evaluate and repair as necessary.

Contact a qualified professional.

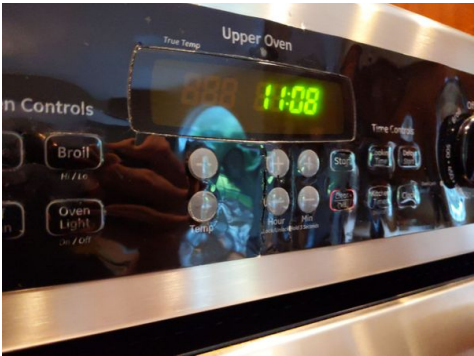
The button covers for the control panel are broken. The unit was functional at the time of this inspection. The covers can be repaired as desired.

Recommendation  
Contact a qualified appliance repair professional.

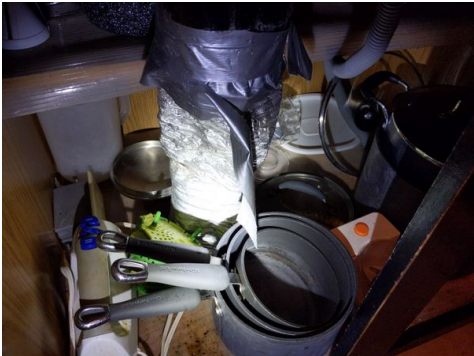
6.6.1 Range Hood

DOWNDRAFT DUCT DAMAGED  
KITCHEN

The downdraft duct in the cabinet is damaged. The duct should be routed with rigid sheet metal material to the exterior.

Recommendation  
Contact a qualified professional.

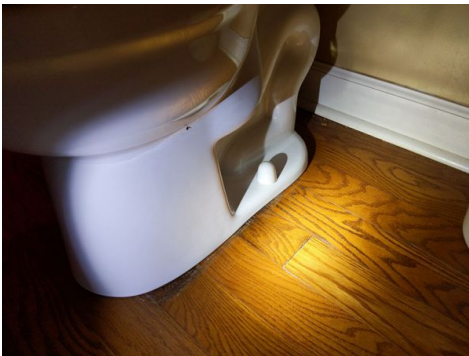
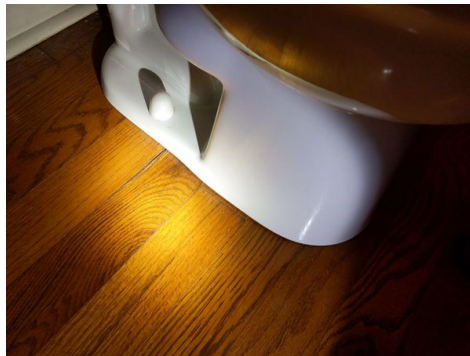
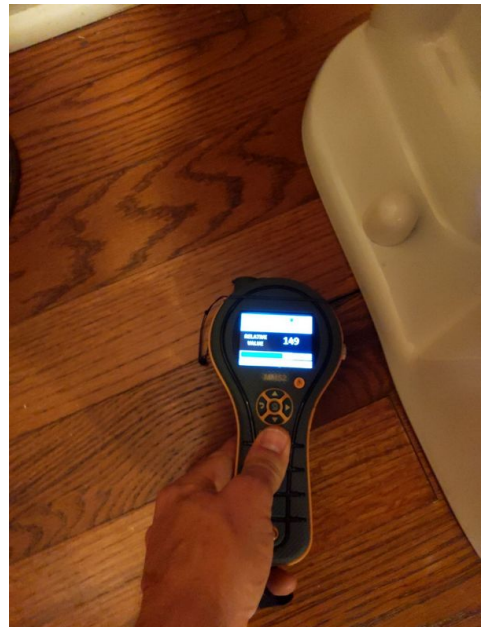
#### 7.6.1 Interior Fixtures

### TOILET: LOOSE / NOT SECURED

Contact a qualified professional.

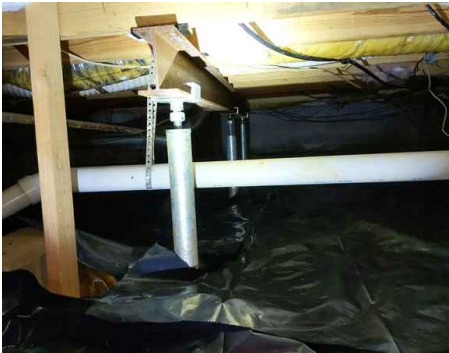
Framing, Posts, and Piers: Repairs Performed [Consult]

Repairs to the framing were observed. Consult with the owner to obtain information regarding any previous repairs performed.

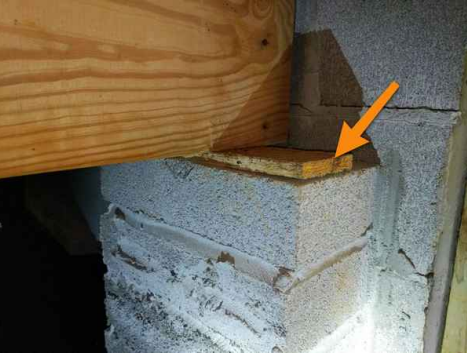
10.3.1 Framing, Posts, and Piers

CONCERNS WITH THE FRAMING SYSTEM

Contact a qualified professional.
