## INSPECTION REPORT

1234 Main St. Knoxville TN 37922

10/05/2021 9:00AM

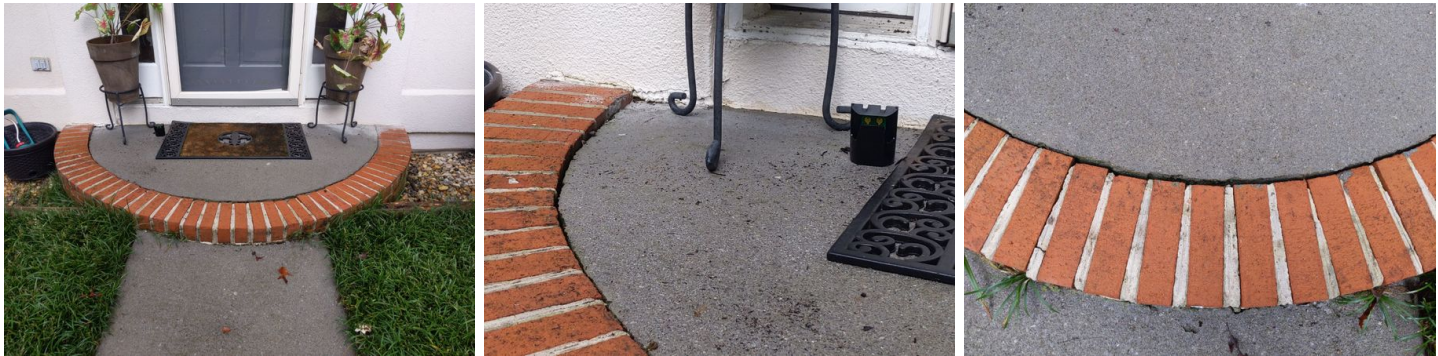
2.6.2 Flatwork

SURFACE: SETTLEMENT AND OFFSETTING

Recommendation  
Contact a qualified professional.

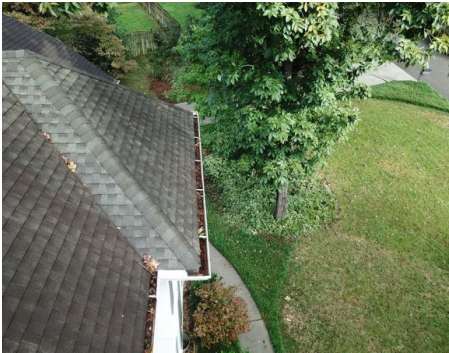
**Gutter System: Gutter Cleaning**  
various locations

Debris needs to be removed from the gutters. This is a common homeowner maintenance item.

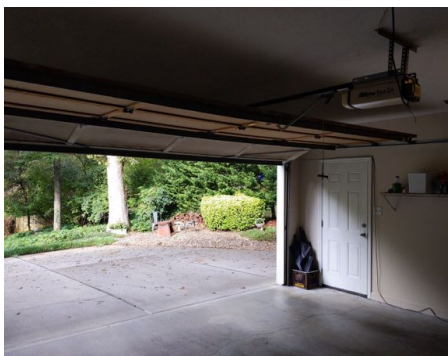
#### Overhead Door : Warning Labels

Some Labels Missing

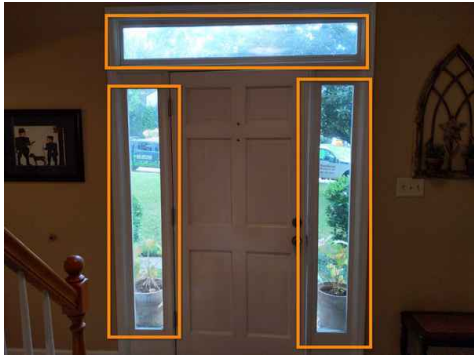
1 - Front door

**TEMPERED / SAFETY GLASS NOT INSTALLED**

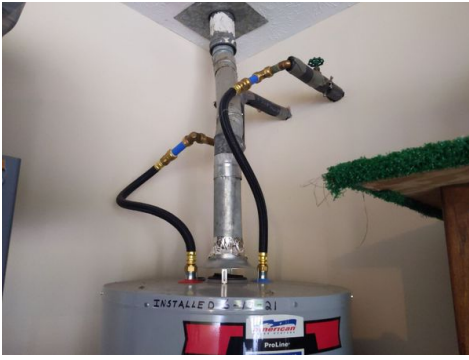
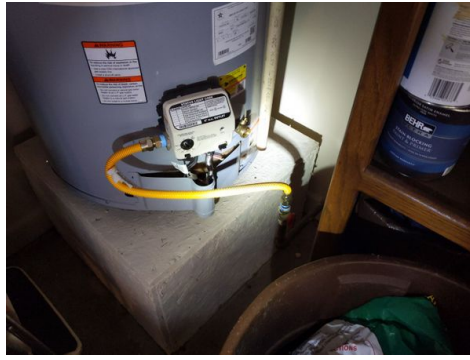
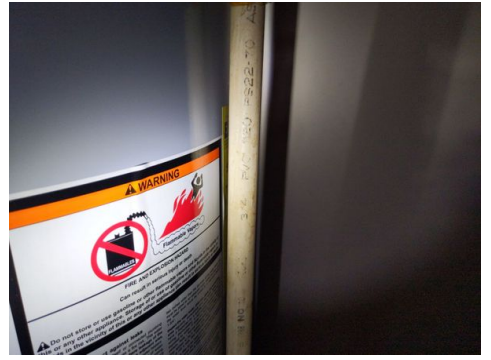
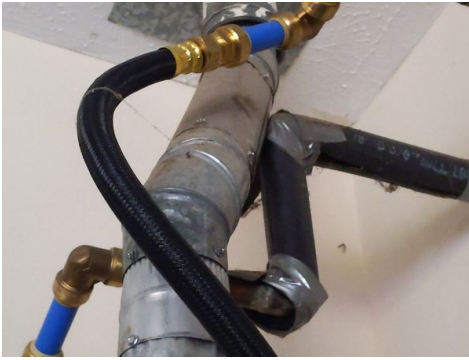
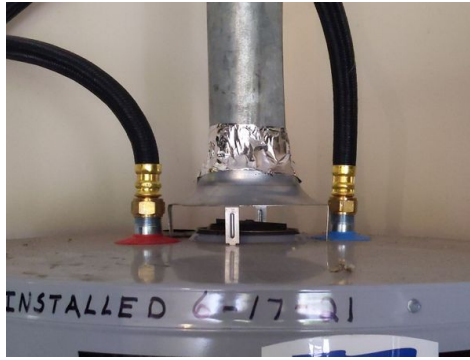
- 1. The water heater temperature and pressure valve does not meet the recommended standards for installation (the drain does not extend far enough to the floor and PVC is not an approved pipe for this application).

- 2. Tape has been applied to the appliance vent piping. Tape is not a proper form of installation or repair. If the fittings on the pipe are correctly installed, the tape does not need to be applied.

- 5. The water heater is installed on a wood block. This is not a preferred material for water heater stands (a non-combustible material is suggested). In addition, the center of the platform is sagging, which may indicate that the old water heater leaked and damaged the framing.

Contact a plumber and/or qualified professional to evaluate and repair as necessary.

Contact a qualified plumbing contractor.

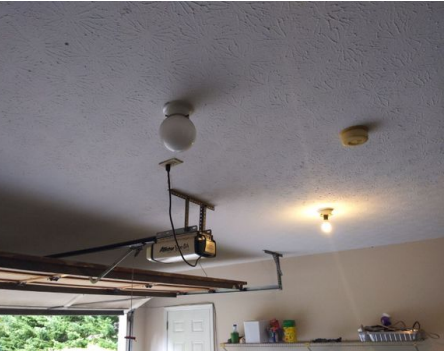
garage

There are lights that are not working. It is likely that the bulbs are burned out. We suggest the bulbs be replaced so that you can verify the operation.

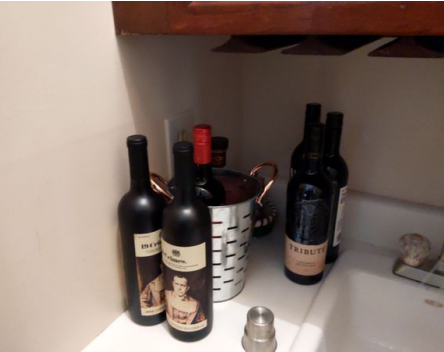
GFCI & AFCI: Unable to Verify GFCI Protection in Some Areas

We could not verify GFCI protection at some locations. An electrician can help to verify protection at all necessary locations.

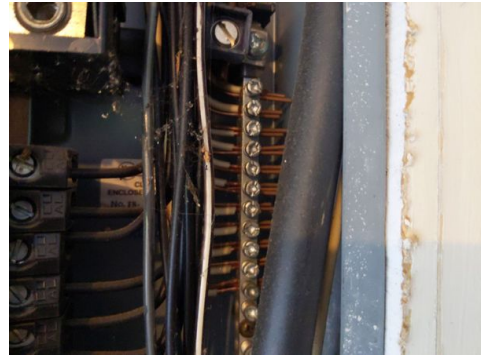
This item does not affect the functionality of the system and can be repaired as necessary (in context with other electrical repairs that may be performed).

Contact a qualified electrical contractor.

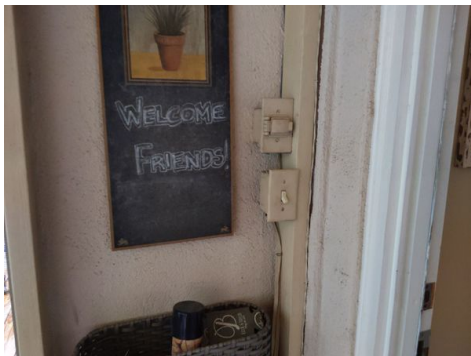
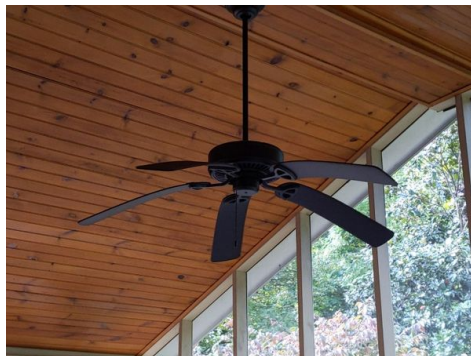
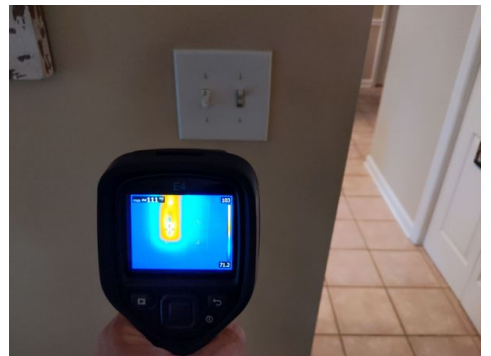
## 8.7.1 Lights and Switches

1. The purpose of the switches at the rear deck were not determined.
2. The ceiling fan paddles at the rear deck are sagging.
3. The dimmer switch is hot to the touch. This is typically an indication that the switch is not properly rated for the circuit or the wattage of the bulbs is too high. Consult with an electrician for repair.

Consult with a licensed electrician and/or appropriate professionals to make all of the necessary repairs to ensure proper safety and functionality.

Contact a qualified electrical contractor.

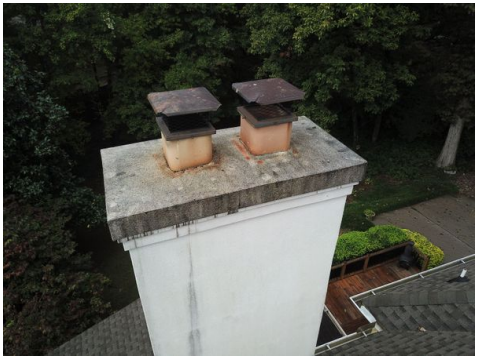
METAL CAP RUSTED

There is rust on the metal cap on top of the chimney flues. This could cause staining to the roof and siding. The caps are suggested to be repaired or replaced as deemed necessary.

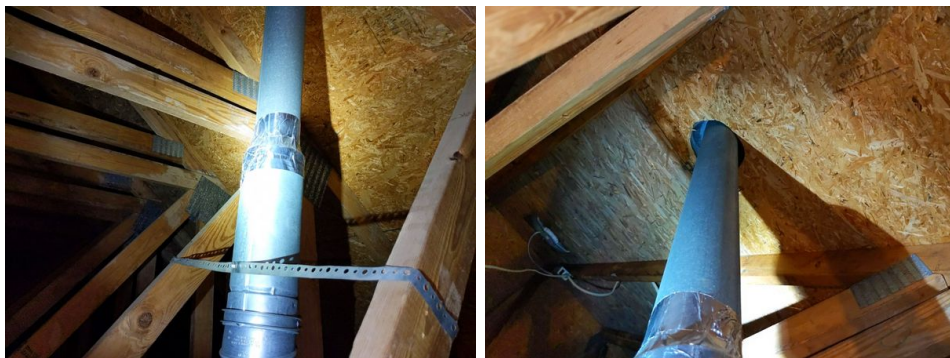
9.9.1 Gas Appliance Vents

CONCERNS WITH GAS APPLIANCE VENTS

- 1. Tape has been applied to the appliance vent piping in the attic and the garage. Tape is not a proper form of installation or repair. If the fittings on the pipe are correctly installed, the tape does not need to be applied. Consult with a qualified professional for further review and to determine if corrective action is necessary.
- 2. The metal vent / flue pipe does not maintain proper clearance where passing through the attic (the framing was too close where passing through the roof). There should be a 1-inch clearance around the vent from building materials. Consult with a reputable contractor to make necessary repairs to achieve proper clearance.

Contact a qualified professional to evaluate and repair as necessary.

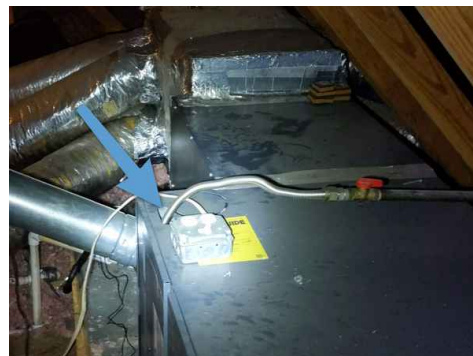
## 9.10.1 Gas Piping

A gas appliance connector is routed through the appliance wall that does not have appropriate protection for the pipe. Appliance connectors routed through the wall of an appliance are suggested to be protected against physical damage (abrasion, cutting, and vibration). This is typically achieved with a protective sleeve attached around the cabinet opening.

Contact a qualified professional.

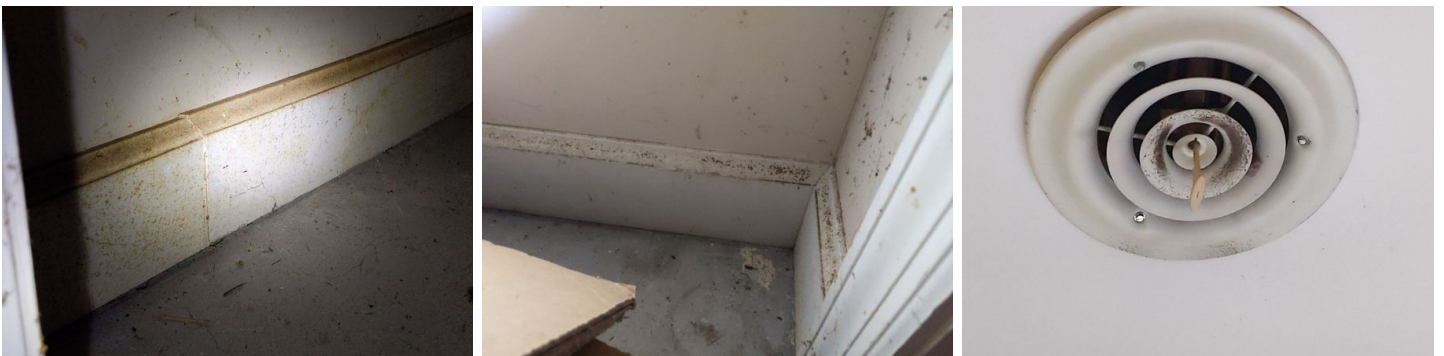
#### 11.4.1 Microbial Growth

### CONCERNS WITH MICROBIAL GROWTH

Contact a qualified professional.
